**FOURTH FIVE-YEAR REVIEW REPORT FOR
WYCKOFF/EAGLE HARBOR SUPERFUND SITE
KITSAP COUNTY, WASHINGTON**

**U.S. Army Corps of Engineers
Seattle District
Seattle, Washington**

**U.S. Environmental Protection Agency
Region 10
Seattle, Washington**

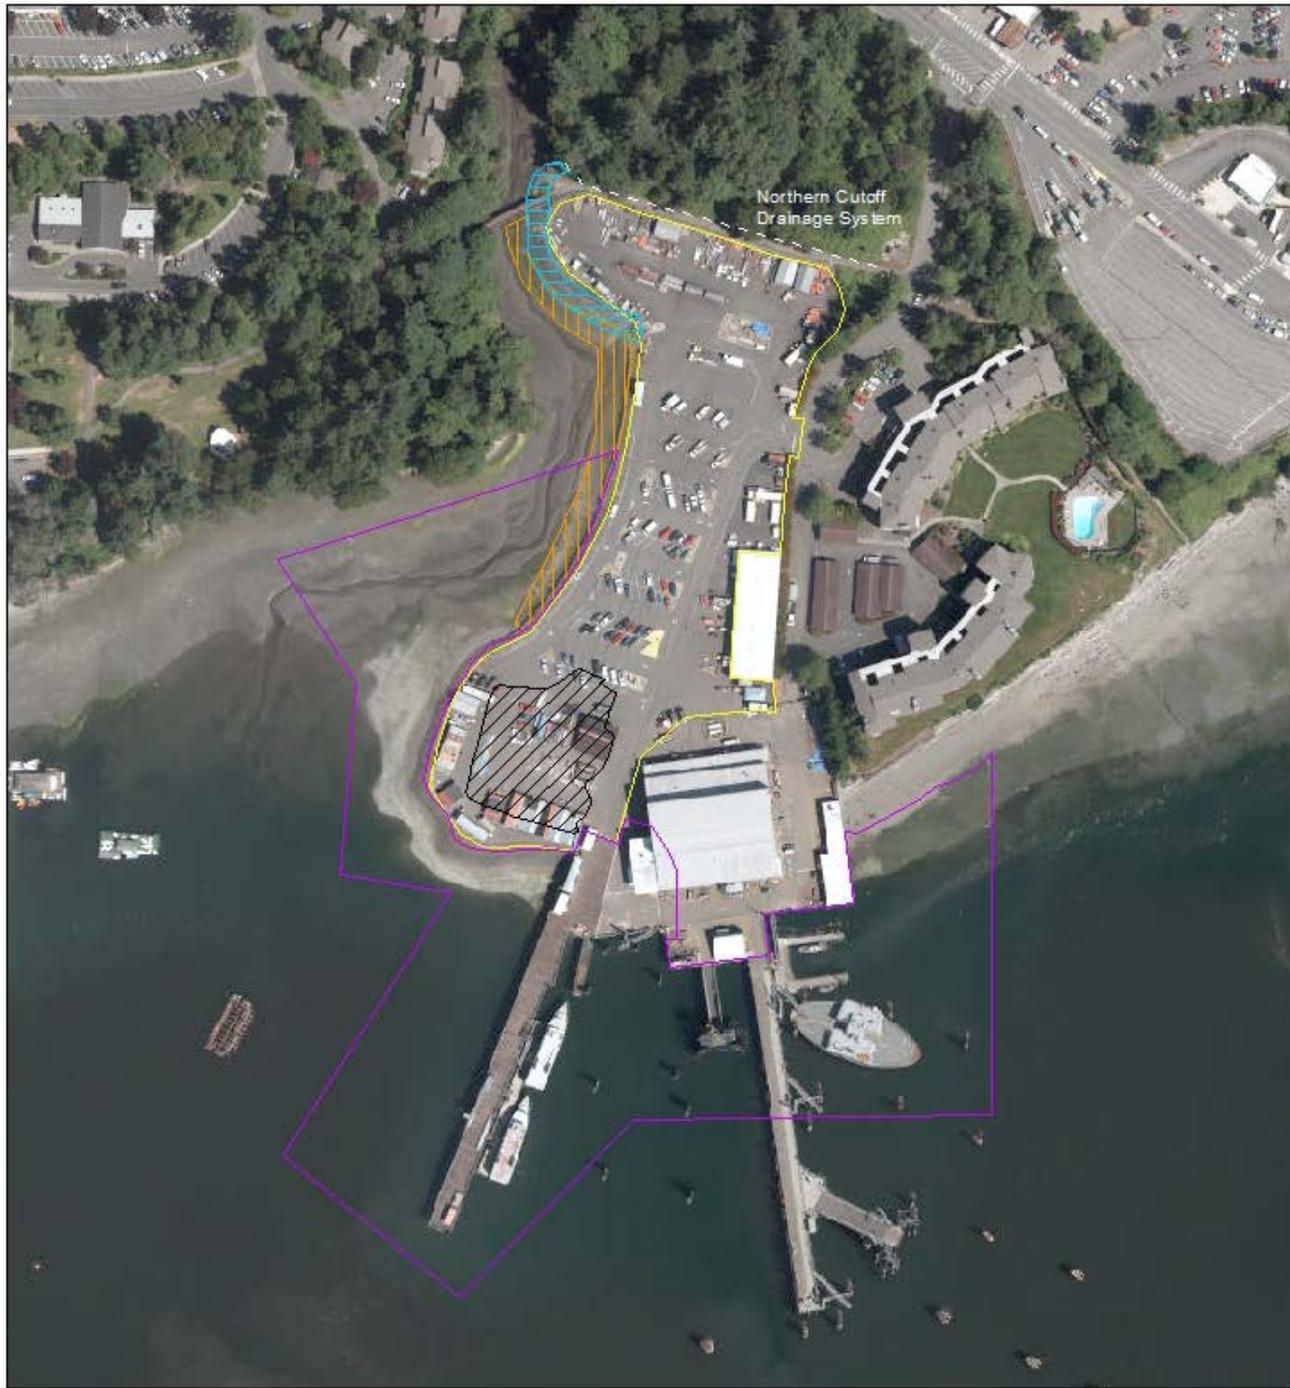
V:\HTRW\5 Year Reviews\5 Year Reviews FY17\R10 Wyckoff Eagle Harbor\04 Drafts\Figures\Fig3_OU-3 Remedy.mxd
 Figure 3. OU-3 Remedy Boundaries

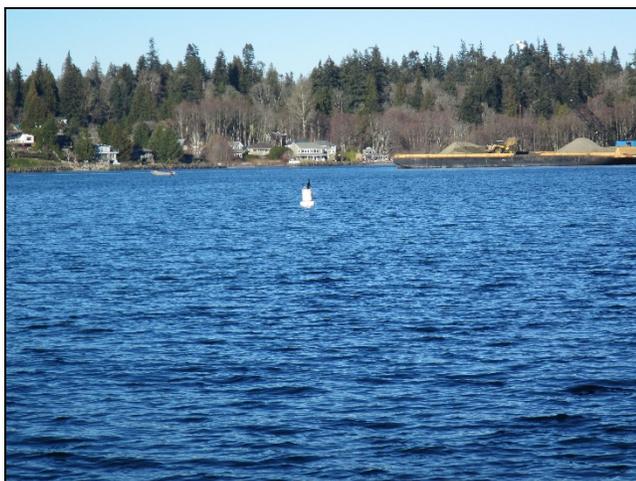
Photo 1. No-anchor buoy

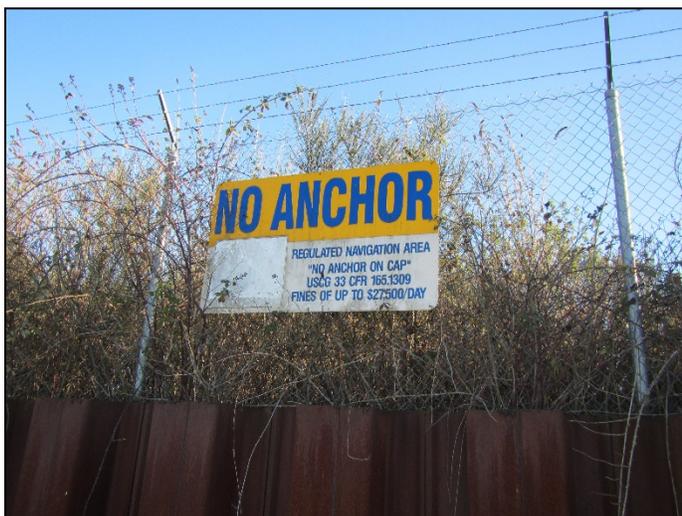
Photo 3. No-anchor sign at the beach

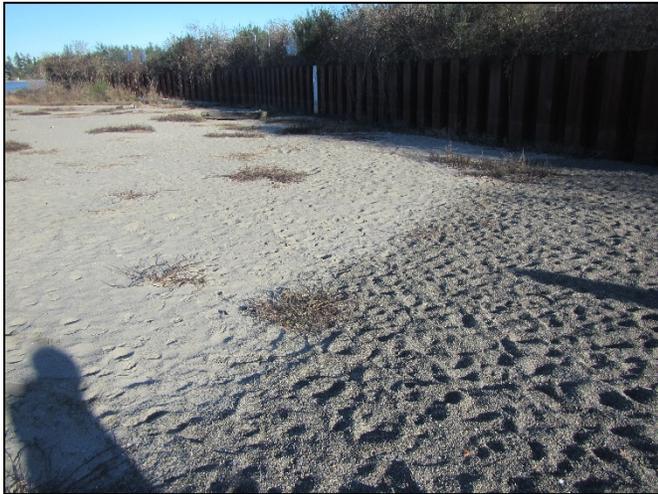
Photo 4. Gravel patch (right side)

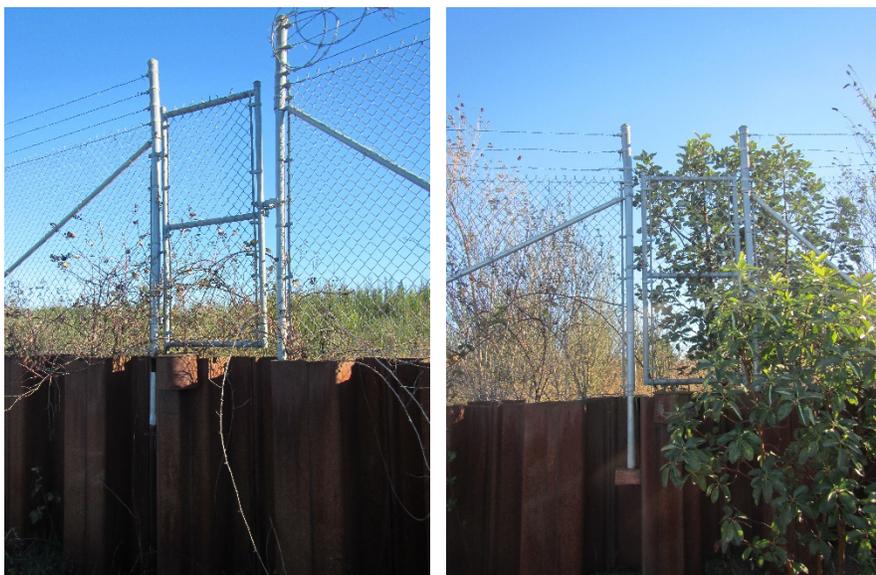
Photo 1. Gates along northwestern wall; vegetation overgrowth in some areas.

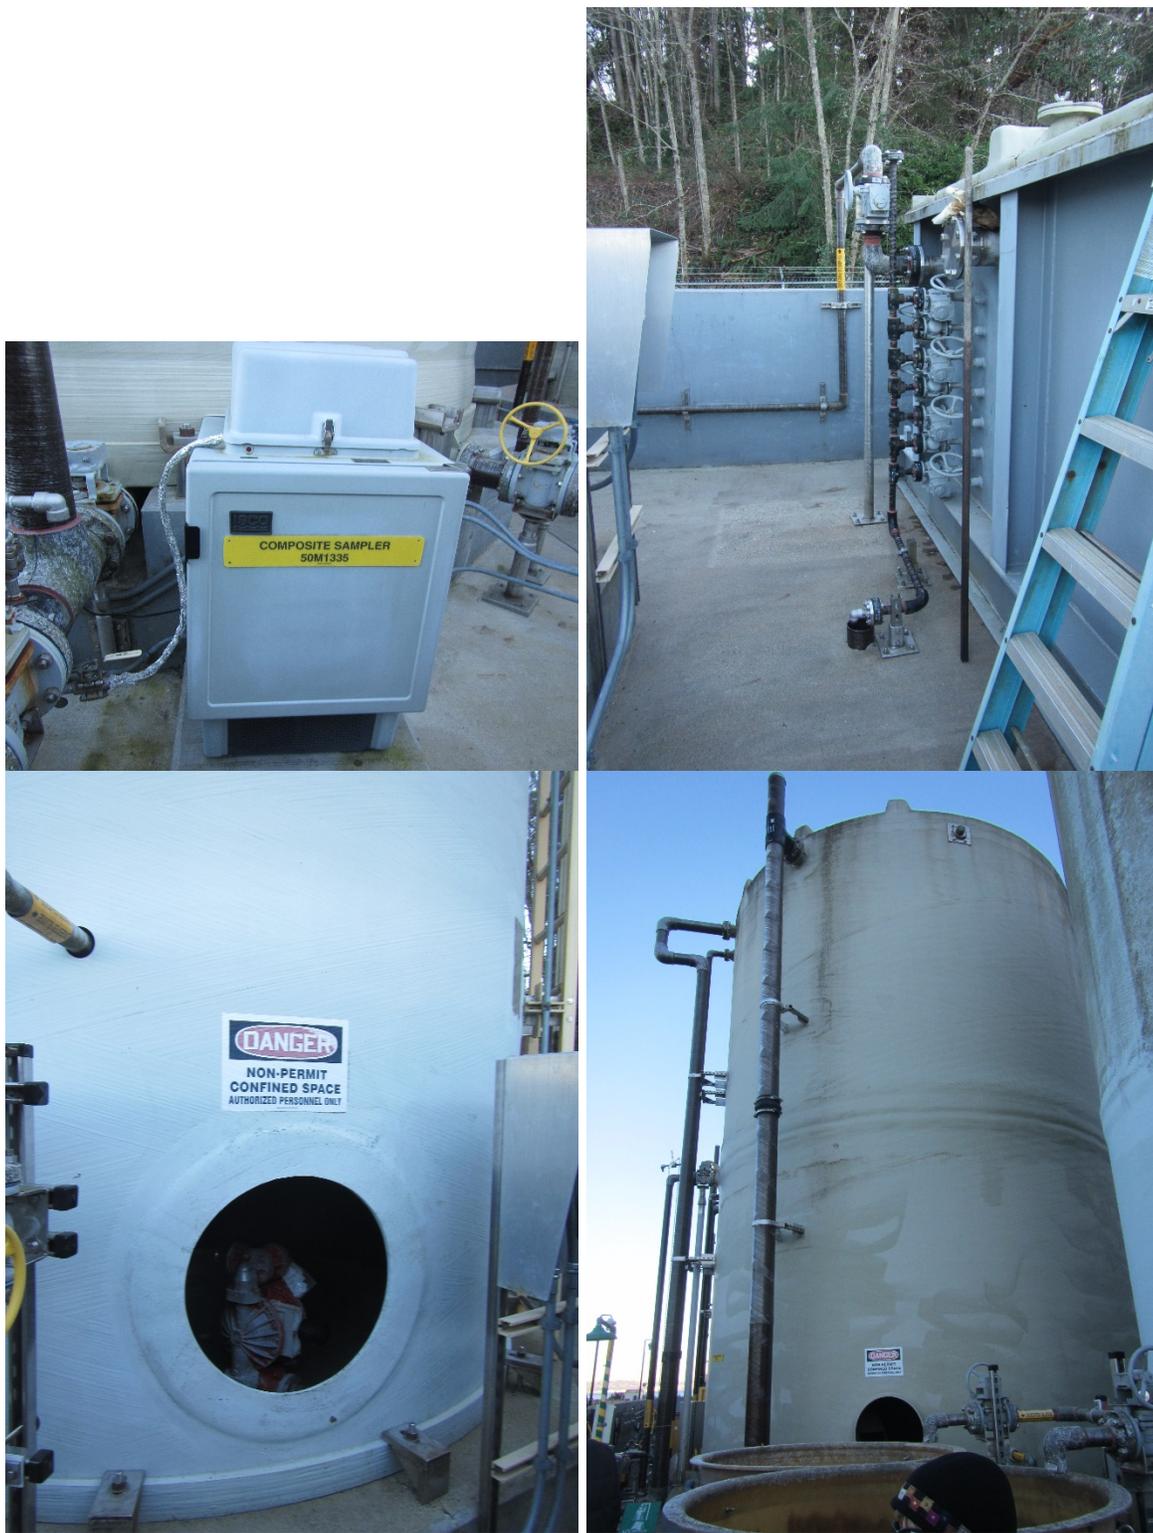
Photo 14. Tank area.

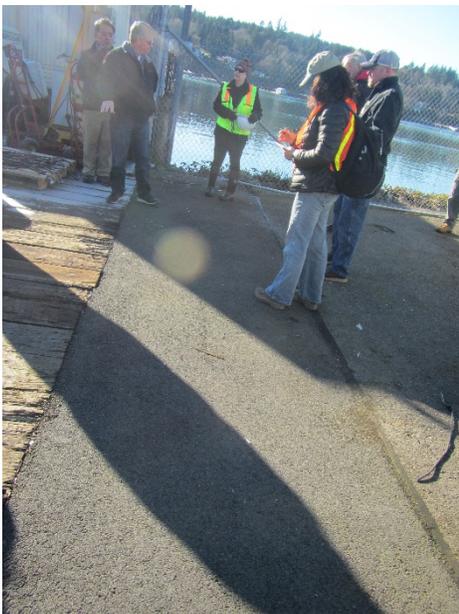
One portion of the asphalt cap has had continued subsidence issues. In 1999, a subsidence was discovered on the southern shoreline adjacent to Pier A (Figure 4) and was repaired with an asphalt patch. An investigation concluded that the subsidence may have been caused either by displacement of fines through tidal action or by differential settlement of the berm material. Additional repairs were made in 2006 and 2009. In 2013, a hole 2 feet in diameter and 2 feet deep formed (Figure 5). A more permanent repair was designed. The August 2013 repair included the installation of concrete locks along the under pier edge to prevent sloughing of fill material. In May 2014, under pier elevation markers were installed to monitor scour and settlement of material near this subsidence area. These markers are now monitored during annual site inspections. As of 2016, no significant erosion has been observed at these markers.

Photo 8. Area of previous subsidence.

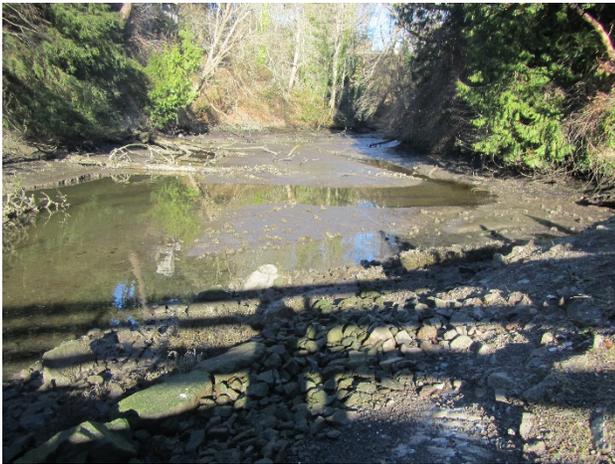
Photo 16. Armor rocks visible in the channel bed.

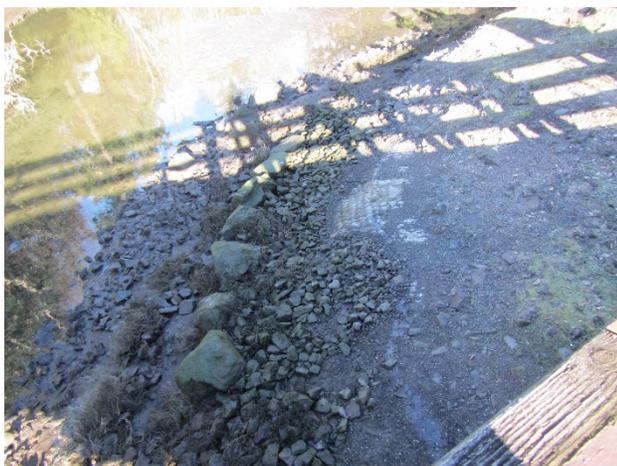
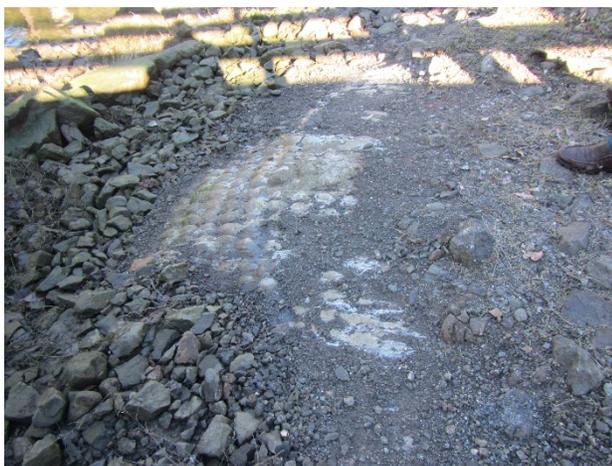
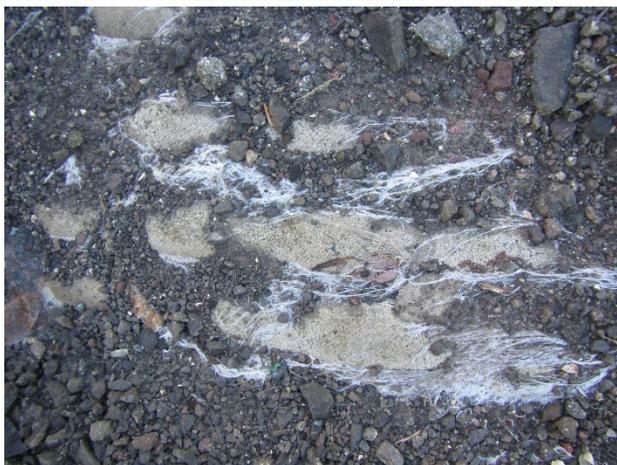
A portion of the shoreline geotextile mat north of and under the footbridge (Figure 4) has continued to be exposed (approximately 25 ft²), and began to show signs of deterioration and cracking in 2012. Repairs were made in August 2013 by placing additional quarry spall and boulders (Figure 6).

Photo 17. Exposed geomat on the tidal barrier.

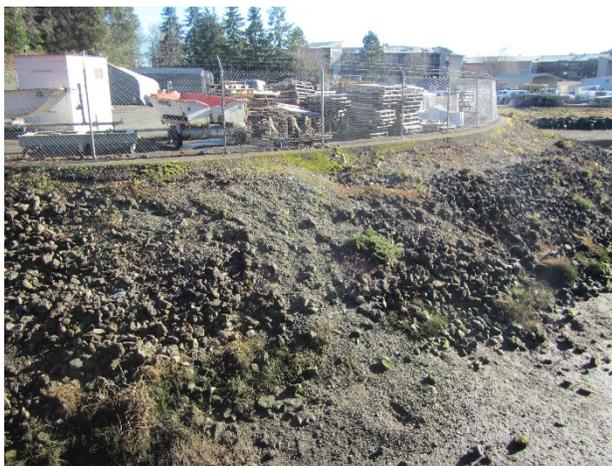
Photo 18. Tidal barrier armoring.

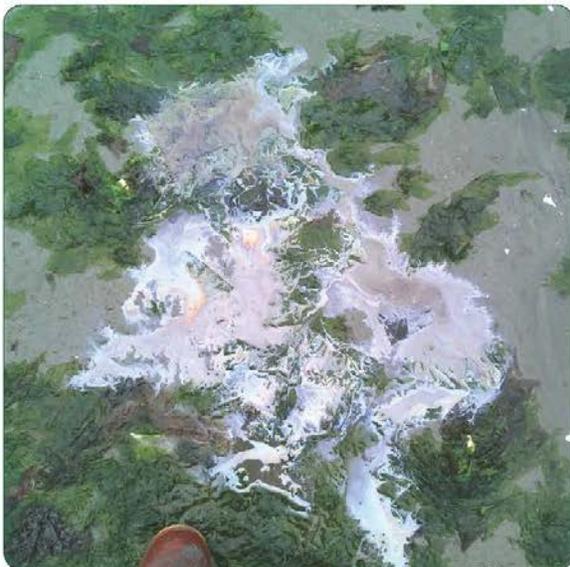
Creosote seep on East Beach with boot for scale
